## Update: Water main and I-694 closure

*December 5, 2017*

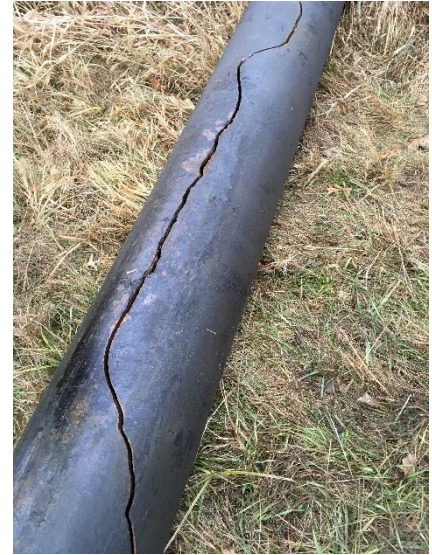
“Now that we reached the point of the removal yesterday, we have been able to start evaluating the cause,” said Shawn Nelson, City of Oakdale Utility Superintendent. “Based on our findings, all joints, and casing appear to be in good condition. It appears that the pipe may have been leaking slightly prior incident, which could be due to several possible causes including movement in the ground, and roadway work.”

Nelson further explained that heaving that happens in the spring and fall due to the weather, which have caused cracks similar to the one pictured (not as long) that appear to possibly be from stress on the pipe. He also explained that it is possible that some of the road work that has happened over the years also attributed to the compensation of the pipe, citing problems with water main issues a few years after roadway reconstruction.

Age of the pipe is not a likely factor in the break, as the old water main was found to be in decent condition.

Crews are actively working toward restoration and completion of the project, which includes full replacement of the damaged section of water main pipe. The site has been prepped and ready for the casement and the pipe has been delivered as of today.
